WOODBURY, TENN.  
N3545—W8600/7.5  
1962  
PHOTO REVISED 1979

## LANDSLIDES AND RELATED FEATURES OF THE WOODBURY, TENN. QUADRANGLE

by  
ROGER E. THOMAS  
1982

U.S. Geological Survey  
Open File Map 82-750 (6-16)

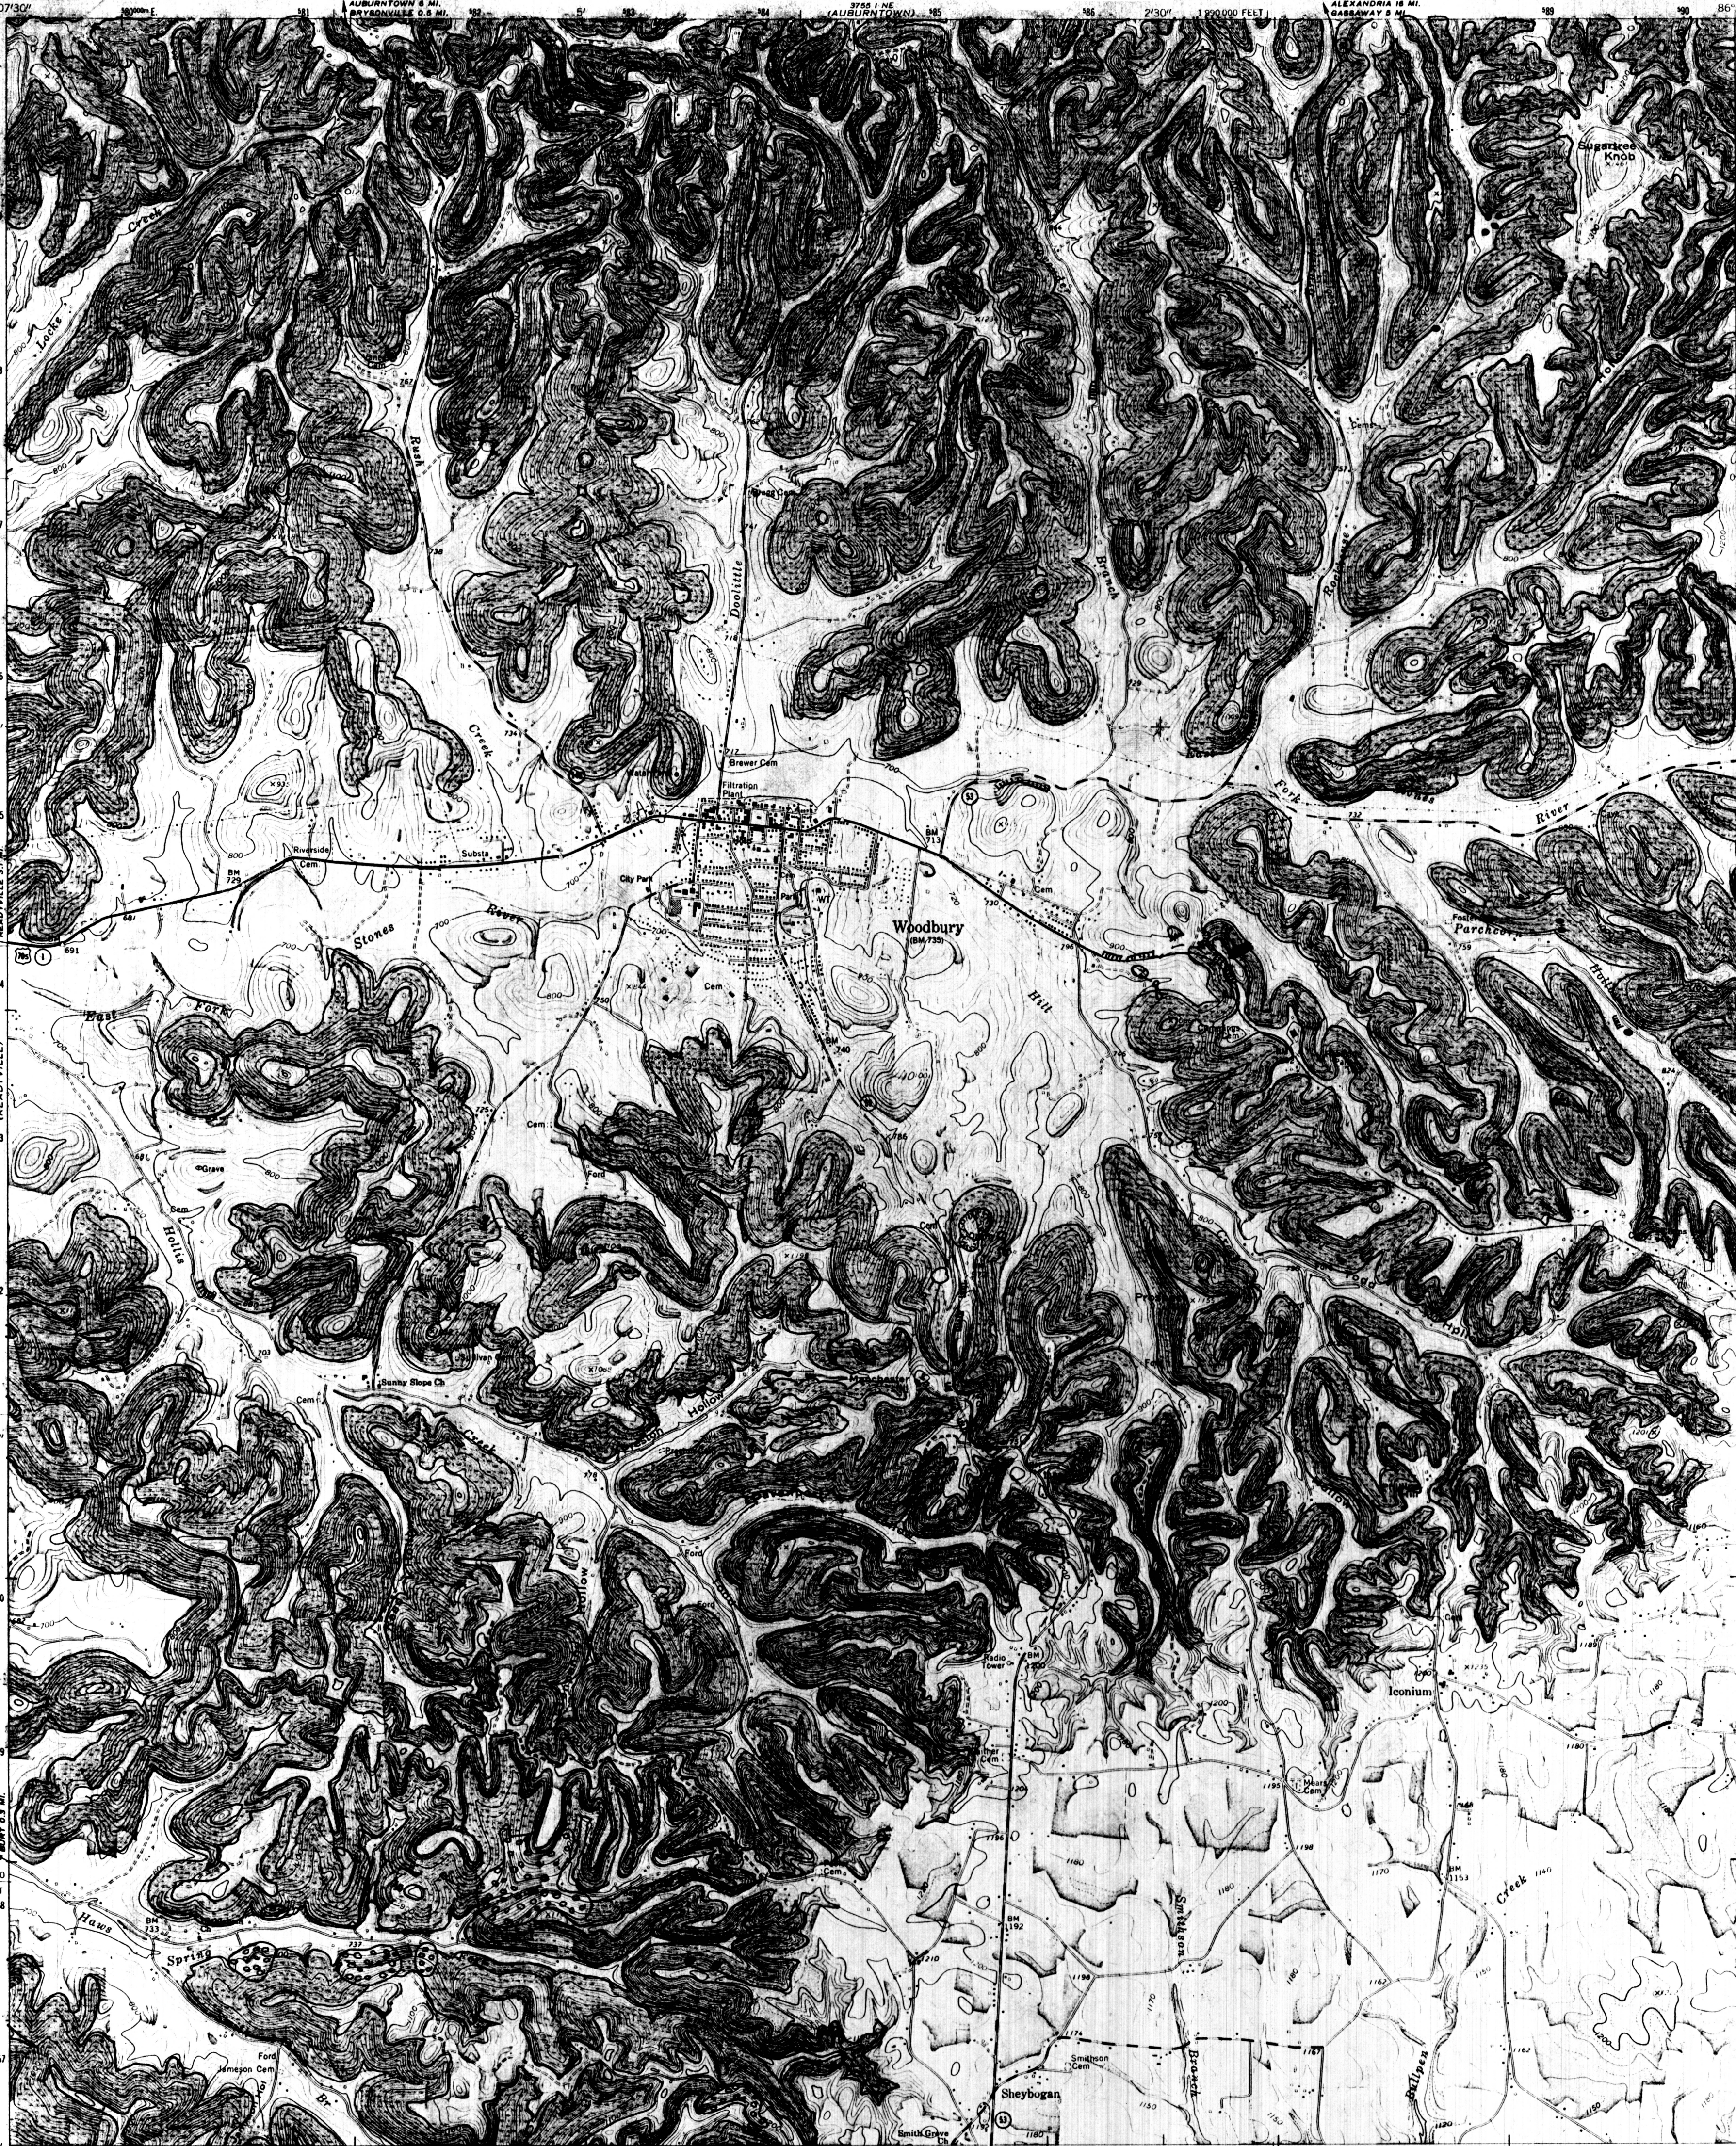
Landslides and related features interpreted  
from aerial photographs:  
1:40,000 (black and white) 1979  
1:58,000 (color infrared) 1980  
Photo interpretation and field check 1980-1981  
This report is preliminary and has not  
been reviewed for conformity with U.S.  
Geological Survey editorial standards.

- ACTIVE OR RECENTLY ACTIVE LANDSLIDE**  
Complex landslide composed of earthflow, debris  
slide, earth and rock slump. Identified from  
historical records, and from scars, debris and  
other field evidence. Ground extremely unstable;  
sliding accelerated by excavation, loading and  
changes in drainage conditions. May include  
areas with several active slides too small to  
be shown separately. Questioned where doubtful.

- OLD LANDSLIDE**  
Area of extensive hummocky ground caused by  
earthflow and earth and rock slump. Lacks  
clear evidence of active sliding. Relatively  
stable in natural, undisturbed state,  
generally not affected by small structures properly  
sited in areas away from the edge of the toe;  
can be reactivated by extensive, rapid exca-  
vation, loading, and changes in ground water  
and surface water conditions. Area of old landslide  
probably includes recent ones not identified  
from field evidence or otherwise documented.  
Upslope boundary of landslide generally defined  
by modified scarp, but downslope (toe) may be  
gradational and not well defined. Questioned  
where doubtful.

- COMBINATION LANDSLIDE**  
Area of recent and old slides in which  
individual slides are not identified.
- COLLUVIAL SLOPE**  
Valley wall along major streams with slope as  
steep as 40° (85%); stony, clayey silt soil up  
to 50 ft. (15 m) thick; commonly buttressed by  
a terrace or bench at the toe of the slope; very  
susceptible to sliding by cutting of toe area,  
removal of terrace or bench, and overloading;  
slide commonly activated without apparent cause.

- COLLUVIAL SLOPES WITH LANDSLIDES**  
Landslides too small or obscure to map  
individually.
- AREAS SUSCEPTIBLE TO DEBRIS FLOWS AND DEBRIS  
AVALANCHES**  
Primarily shallow, narrow ravines and chutes with  
accumulation of stony colluvium generally 10 ft.  
(3 m) or less in thickness; susceptible to rapid  
movement during intense rainfall. Most ravines  
and chutes designated show evidence of former  
debris flows and avalanches.

- AREAS SUSCEPTIBLE TO ROCKFALL**  
Steep, locally vertical, natural and man-made  
slopes and cliffs, 15 ft. (4.5 m) or more high;  
formed dominantly of sandstone, limestone, sandy  
shale, mudstone and claystone. Interbedded mud-  
stone, claystone and shale weather rapidly leaving  
sandstone and limestone rock faces unsupported.

- SOIL AND ROCK SUSCEPTIBLE TO LANDSLIDING**  
Soil and rock similar to that involved in land-  
slides elsewhere in map area; primarily areas  
underlain by claystone, mudstone and shale  
associated with other rock types. Rock weathers  
rapidly on exposure forming clayey soil highly  
susceptible to sliding. Includes coves (U-shaped,  
shallow valleys) containing thick layers of clayey  
soil that are very susceptible to sliding where  
excavation breaks continuity of slope and where  
overloaded by artificial fill.

**AREAS LEAST PRONE TO LANDSLIDES**  
Map areas in which no patterns or symbols are shown;  
primarily valley floors, ridge tops and broad  
benches; modification by excavation and fill may  
lead to local landslides.

- MAN-MADE FEATURES**  
Strip mines (combination of letter symbols  
indicates complex formed of more than one  
type of strip mine)  
sh bench with high wall  
sf furrowed with high wall  
sd multiple furrows and multiple benches  
ss hilltop removed  
srg reclaimed by grading  
sru reclaimed by secondary use  
sf/r regraded in part, high wall  
remains  
Coal refuse banks  
r identified on aerial photographs;  
not classified in field check  
rb not burnt nor on fire  
rbb burnt  
rbd burning  
rbs sludge  
Quarries  
q quarry site  
qub spoil bank, quarry waste  
Gravel pits  
g site of gravel pit  
Slides in man-made features  
af earth flow in fill

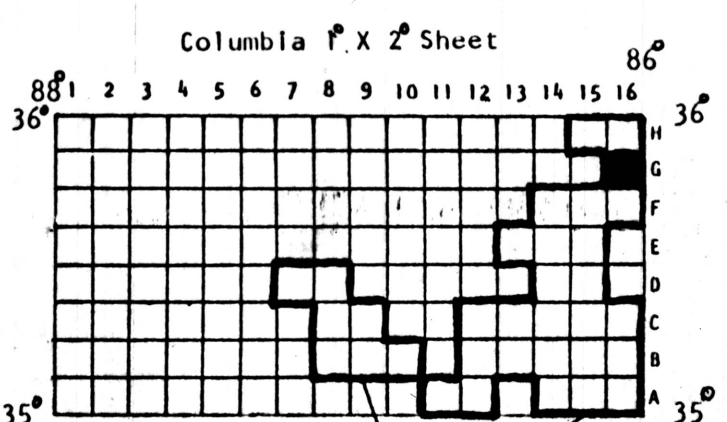
The first five digits of the open file number designate the  
specific 1:250,000 scale map sheet of which this quadrangle  
is a part. The last two digits designate the position of the  
quadrangle in a subdivision of the 1:250,000 scale map based  
on rows and tiers shown in the diagram to the right. The  
location of this quadrangle is shown by the black square.
